# Esthetic Rehabilitation of Anterior Teeth with Porcelain Laminates and Sectional Veneers

Marco Gresnigt, DMD, MSc; Mutlu Özcan, Dr Med Dent, PhD

### Case Report

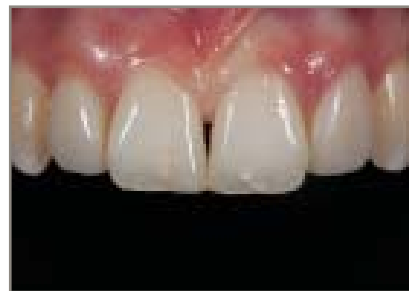
anterior teeth, cervical marginal discoloration of the composite and the appearance of a black (i.e., open) triangle between the central incisors. Another dentist had placed the restorations several years previously to restore her peg-shaped lateral teeth (**Fig. 1**), using a microhybrid resin composite. She reported that during the restoration process, her maxillary right canine had been damaged by the diamond bur used for finishing the restorations, but the damage had been left untreated (**Fig. 2**).

**Figure 1:** Intraoral view, showing the fracture on tooth 12, damage on the mesial side of tooth 13, the black (open) triangle and discoloration of the outlines of the direct composite resin veneer.

Treatment options were discussed with the patient. As a dental student, she was conscious of the benefits of preserving the dental tissues, and she did not want to sacrifice sound enamel. However, she had certain expectations about the final position, colour and surface texture of the teeth. The following comprehensive treatment plan was adopted: remove resin composite restorations, make impressions, roughen the teeth, control the fit of the restorations and adhesive cementation, and perform finishing and polishing of the bonded porcelain restorations.

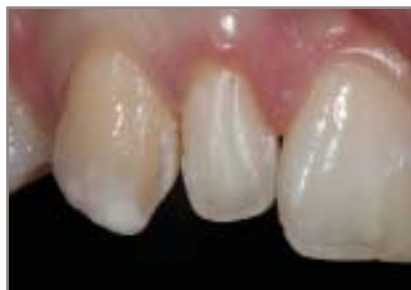
**Figure 2:** Close-up photograph after removal of the direct resin veneer. Apparent damage on tooth 13 was reported to have occurred during finishing of the previous composite restoration.

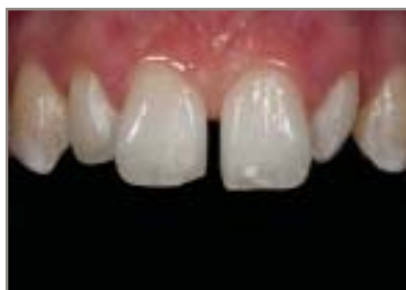
In this case, an incisal overlap preparation was selected, to give the dental technician maximum control over esthetic characteristics and translucency. For the sectional veneers, no preparations were performed, except for removal of the resin composite restorations (Fig. 3). Although the

**Figure 3:** Intraoral view after removal of the direct resin composite restorations.

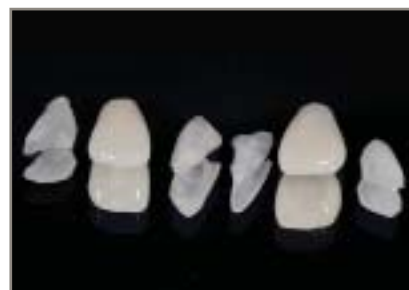
**Figure 4:** Porcelain laminates and sectional veneers prepared on the refractory dies.

For fabrication of the laminates and sectional veneers (Vintage Al porcelain, Shofu, Kyoto, Japan), Nori-vest-alumina refractory dies (Noritake, Miyoshi, Japan) were used, in combination with alveolar models, to achieve better harmony with the gingival outline. Glass ceramic restorations were baked on the refractory dies. For the sectional veneers (0.01–0.5 mm thickness), small portions of dentin and various translucent ceramic powders were mixed according to the manufacturer's instructions (Fig. 4). The porcelain laminates were 1 to 1.5 mm in thickness because of the coned tooth morphology. Restorations on these teeth required the use of a significant amount of dentin porcelain. The porcelain surfaces were stained for a natural-looking surface texture. The restorations were finished using stones (Dura-green stones, Shofu), diamond burs and abrasive papers (Meister Cones, Noritake), and a final fine polishing was performed with Pearl Surface F paste (Noritake).

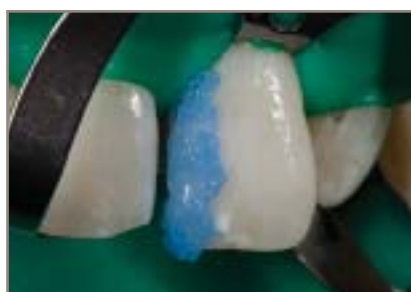
**Figure 5:** Etching of a tooth with phosphoric acid.

Before any adhesive procedures were applied to the teeth, the superficial outer layer of enamel was removed with diamond burs. After preparation, the enamel surfaces were conditioned with an etch-and-rinse adhesive bonding procedure, specifically, etching with 38% phosphoric acid (Ultradent, South Jordan, UT) for 30 seconds, followed by application of an adhesive (Excite, Ivoclar Vivadent) (Fig. 5).

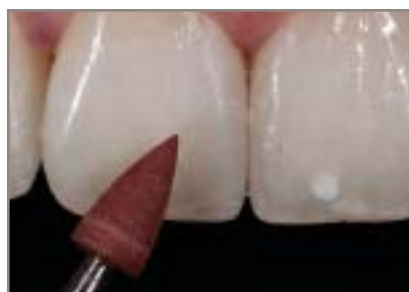
**Figure 6:** Finishing and polishing with a rubber point.

For sectional veneers, which are very thin restorations, the thickness of the luting cement may affect the distribution of stress at the interface between the adhesive and the restoration.<sup>7</sup> If the internal fit of an indirect restoration is poor, higher stresses may occur at this interface.<sup>7</sup> In this case, the adaptation of the restoration was controlled under microscopic examination. In addition, during the laboratory procedures, no dye spacer was used, so as to achieve optimal adaptation of the restoration with minimal thickness of resin composite cement. Adhesive cement was applied on the inner surfaces of the restorations before insertion. After removal of excess cement, glycerine gel was applied at the margins to prevent an oxygen inhibition layer. The restorations were photopolymerized from the buccal and palatal directions. Excess resin composite was removed with an explorer, and the margins were finished and polished with diamond burs, rubber points (Fig. 6) and diamond polishing paste. The final result met the patient's expectations (Fig. 7). ♦

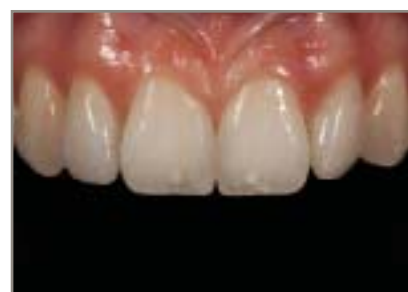
**Figure 7:** Final intraoral view after placement of the porcelain laminates and sectional veneers.
